# FMCW THz Potential

## CALIBRATION | Samples with induced defects

# TD THz Potential

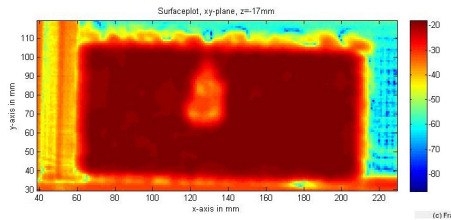
C-Sandwich sample (H/C) with water inclusions in one core.

### Backside Inspections

Infrared Thermography

Better results with FMCW THz when the backside is inspected, compared to IRT (Infrared Thermography) or UT immersion.

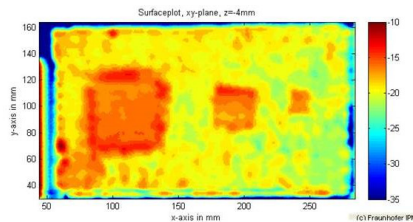
A-Sandwich sample (H/C) with debond between adhesive & core.

Radiography

Slightly better general results of relative detection for the FMCW THz system, compared to RT (radiography), IRT (infrared thermography) and UT (immersion).

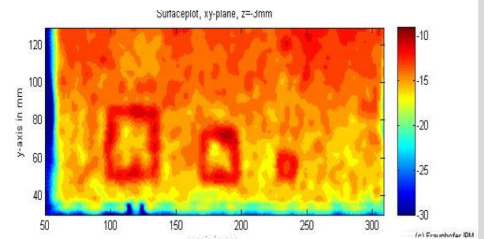
A-Sandwich sample (RHC) with debond between skin & adhesive sheet.

Infrared Thermography

Better general relative results of detection for the FMCW THz system, than IRT and UT (immersion or air-coupled) / No results by RT (radiography).

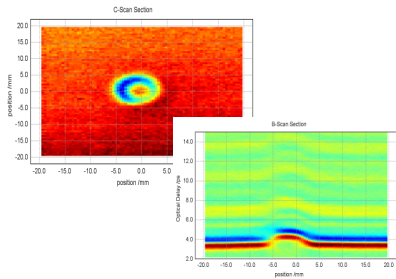
GFRP solid laminate with impacts.

Better results with TD THz, compared to RT (radiography).

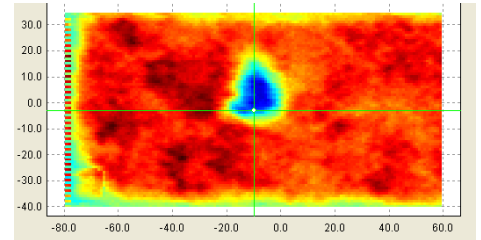
C-Sandwich sample (H/C) with water inclusions in one core.

Better results with TD THz compared to RT (radiography) and to Infrared Thermography when backside is inspected in transmission.

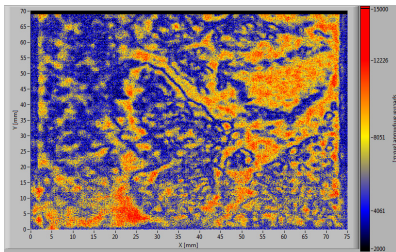
Rain erosion coating. Surface contamination by oil.

Infrared Thermography

Better detection contrast than RT (radiography) and IRT (thermography IR). No detection by ultrasound (UT) NDT techniques.

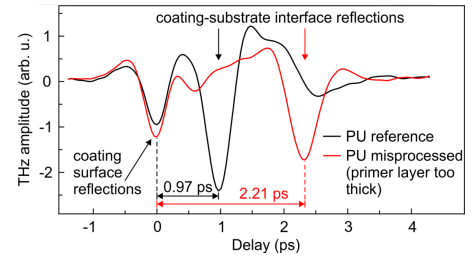
Polyurethane coating, incorrect primer layer thickness 60 microns - 100 microns.

Radiography

Better results of detection contrast and level. None of the used NDT conventional techniques have provided positive detections.
